Discovery STS-114

SSME Flight Readiness Review

June 29-30, 2005

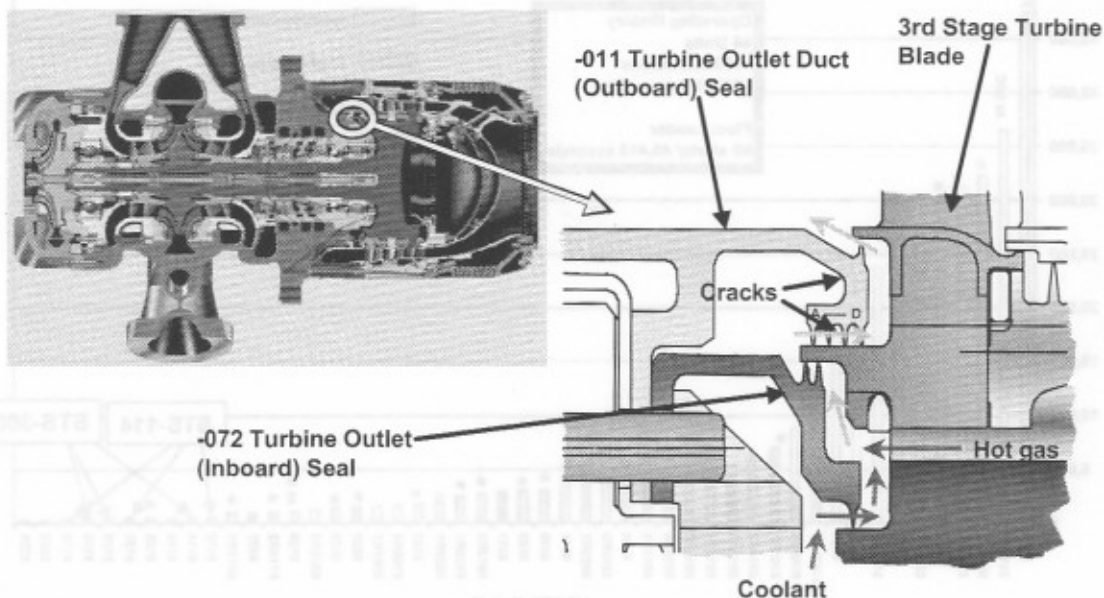
Outboard Seal (-011) Cracking

- **Issue**
 - Cracking of Turbine Outlet Duct Seal creates FOD concerns to downstream components
- **Background**
 - Multiple seals found with radial cracks in 4-tooth seal during overhaul and recycle operations
 - 3 flight configuration seals
 - Severity varies from single crack in one tooth to multiple cracks in all four teeth
 - 2 non-flight, early development configuration seals
 - Multiple cracks in all four teeth
 - Single occurrence of circumferential web cracking
 - Intermittent, 360 degrees, one location with through crack
 - Cracking had no impact on seal functionality or engine operation
 - No FOD generated

- **Investigation / Analysis**
 - Materials analysis indicates high cycle fatigue failure mechanism
 - High dynamic vibratory load / flutter
 - Supported by analysis, flutter rig, and hot fire testing
 - Single occurrence of web cracking correlated to assembly error and unique operating conditions
- **Sustaining Flight Mitigation Actions**
 - Assembly build clearance verification
 - Green run data review to screen for flutter response frequencies
 - Implement life limit / inspection requirement to maintain margin on demonstrated experience
 - 50% / 25% of lowest time cracked unit

- Rationale for Flight
 - All flight HPOTPs retrofit with new seals
 - Seal clearances verified to be within family
 - No evidence of flutter frequency during green runs
 - Life limit and inspection interval provides margin against seal failure (loss of material)
 - No occurrence in program history
 - Demonstrated hot fire operation with seal cracking (5 units) to a minimum of 4457 seconds
 - DAR PW0311R1 allows maximum of 1274 seconds (with waiver) prior to inspection

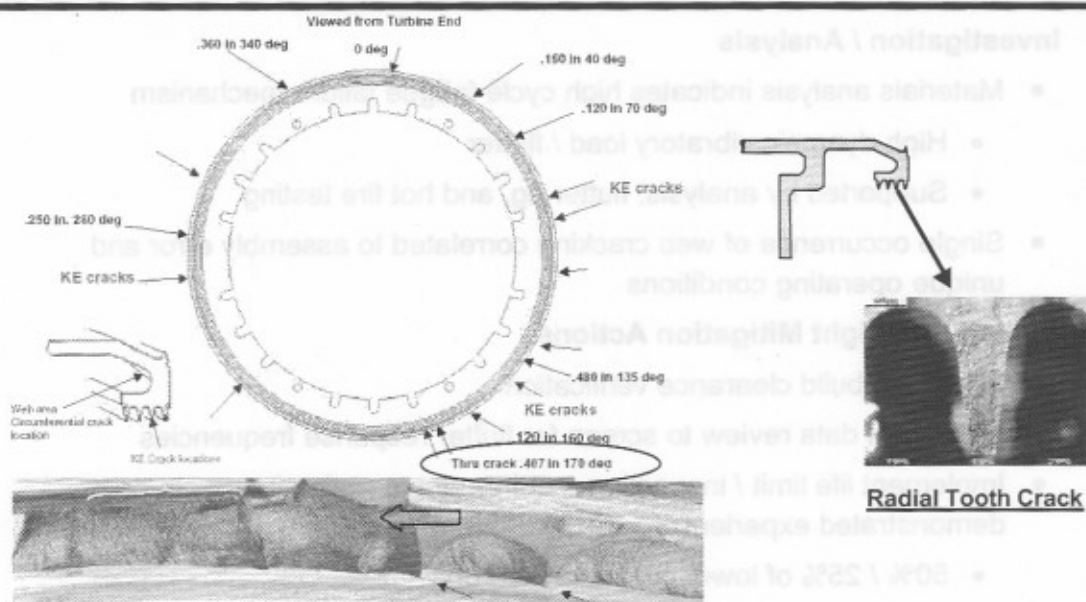
HPOTP 8016R4 Outboard Seal (-011) Crack Indications

One web through crack showing crack growth deceleration

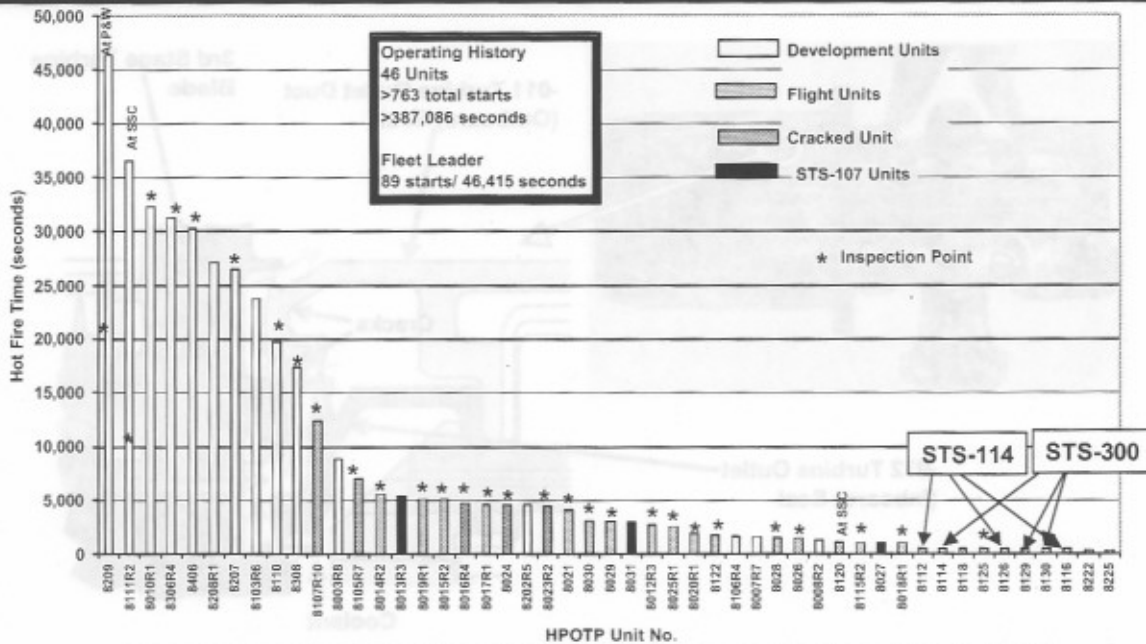
HPOTP Knife Edge Seal Outboard Seal (-011) Cracking

STS-114 units very low time relative to demonstrated experience with cracking

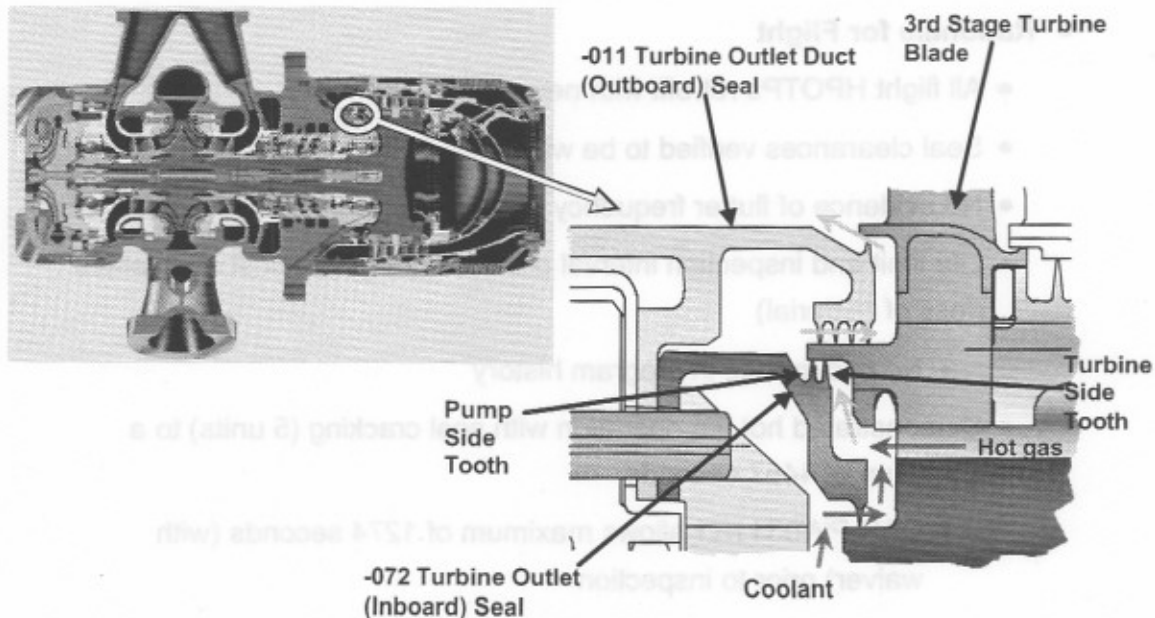
Inboard Seal (-072) Cracking

- Cracks and material loss found in knife edge 2-tooth seal during scheduled overhaul of 5 flight HPOTPs
 - Pump side tooth cracking and material loss on 4 of 5 seals
 - 3 of 5 had turbine side tooth cracking also (no material loss)
 - Pump side tooth cracking only (no material loss) on one seal
- Cracking and material loss had no significant impact on seal functionality or engine operation

- Investigation / Analysis
 - Materials analysis indicates high cycle fatigue failure mechanism
 - High dynamic vibratory load
 - Supported by analysis, laboratory air flow tests, and flutter rig test
 - Pump side only tooth loss has negligible impact on overall seal performance / functionality
 - Significant turbine side tooth loss in combination with pump side tooth loss could impact outboard seal (-011) stability
 - No history of occurrence
 - FOD assessment indicates large margins to catastrophic failure
 - Particle size limited by operational seal clearances
 - > 10 factor to critical HEX impact mass
 - Analysis anchored to ballistic tests

- All flight HPOTPs retrofit with new seals
- Large margins to potential FOD damage from pump side tooth failure
- Life limit and inspection interval provides margin against -072 turbine side tooth failure (loss of material) and -011 seal instability
 - No occurrence in program history
- Demonstrated hot fire experience with seal cracking (5 units) with times between 1811 and 5644 seconds
 - DAR PW0365R2 allows maximum of 1274 seconds (with waiver) prior to inspection

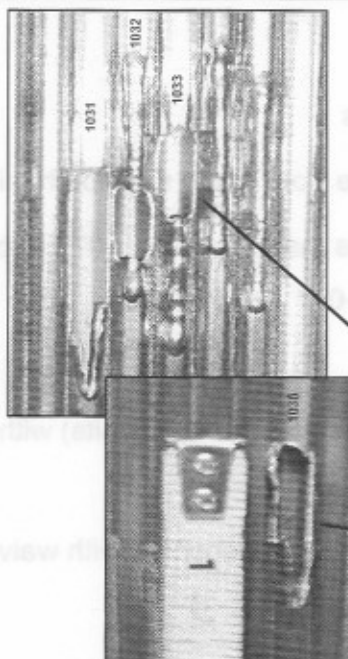
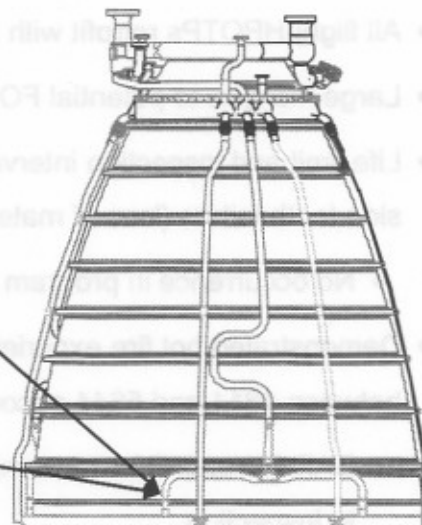
(Tubes 1031, 1032, 1033 and 1036)

- Tube Ruptures located in the 10th bay

- **Unique thermal processing (Uralite bake-out)**
 - Reduced ductility of braze alloy used in previous tube repairs
 - Confirmed with fractography from N5007 fracture surface
 - Atypical overload fracture through overlay centerline
 - Qualitatively duplicated in the lab with bend tests on exemplar repair specimens
 - "As repaired" fractures highly ductile
 - Brittle, limited ductility fractures following 5 hour simulated furnace bake cycle
 - Comparable discoloration as noted in N5007 fractures (gold vs. typical silver)
 - Quantitative verification with tensile specimens
 - Confirmed 63% reduction in ductility
 - Metallography verified nominal material in N5007
 - A-286 tubes, nickel plating and Nicro braze

- **Preliminary Flight Rationale**
 - Nozzle 5007 tube ruptures caused by unique thermal processing
 - Condition does not exist on STS-114 nozzles
 - Comparable tube repairs on STS-114 nozzles have all completed hotfire with no anomalies
- **Forward Action Plan**
 - Complete fault tree and verify closure of all branches
 - Complete laboratory materials analyses of other potential failure mechanisms (ie. anomalous welding)
